Volume II

Appendix D.15

Maintenance, Material, and Management Inputs

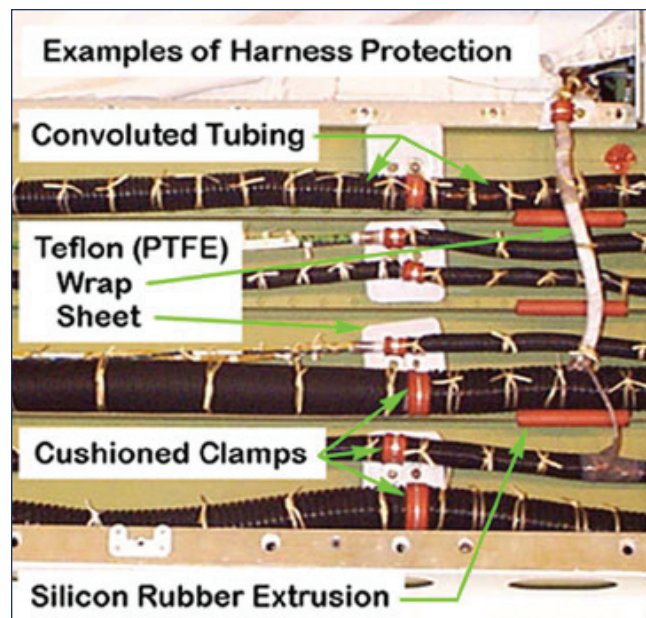
Wiring nonconformances can be corrected several ways: re-routing, reclamping, or installation of additional insulation (convoluted tubing, insulating tape, insulating sheets, heat shrink sleeving, abrasion pads, and so forth). (See Figure 1.1.2) Additionally, testing of Orbiter wiring under normal operating loads has shown arc tracking in bundles usually stops due to wire separation (as opposed to circuit protection devices tripping). Further testing under conditions approximating the Shuttle wiring environment also showed that, after separation, arc tracking did not progress beyond six inches. Based on these results, Boeing recommended NASA separate all critical paths from larger wire bundles and individually protect them. This protection should extend a minimum of six inches beyond the confluence of critical paths.³ This is being implemented during OMMs.

Figure 1.1.2. Examples of Harness Protection.

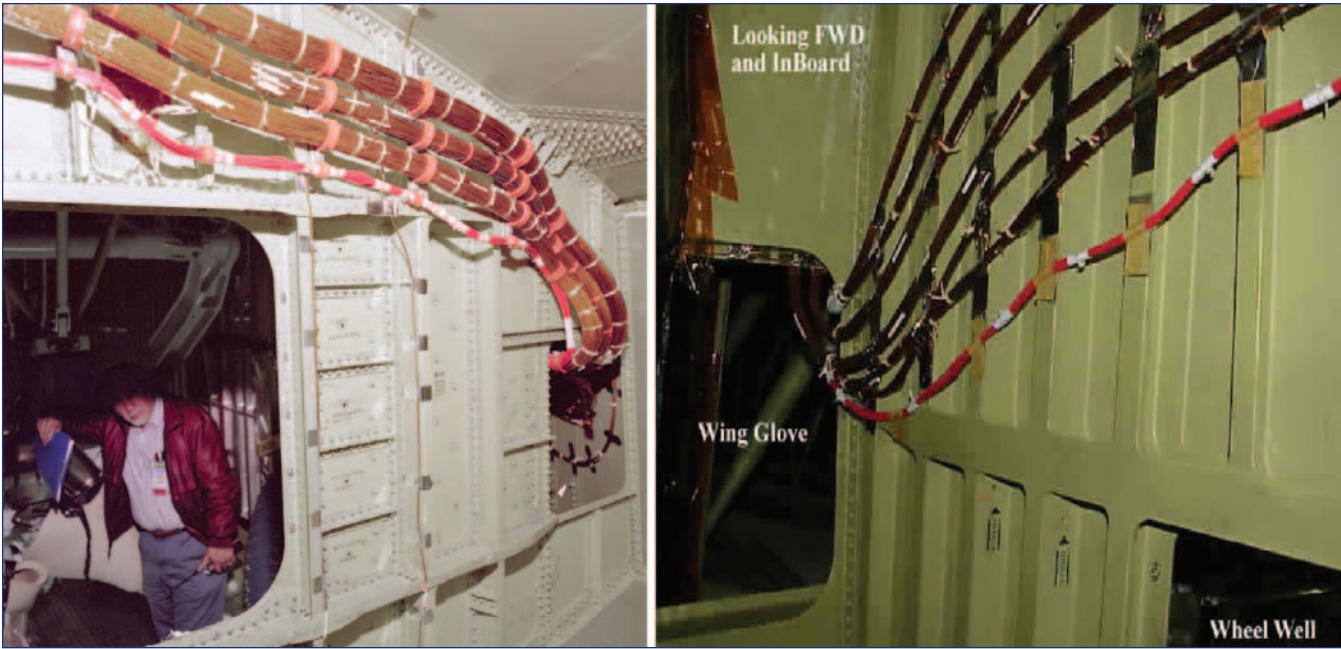
Analysis of telemetered data from 14 of *Columbia*’s left wing sensors (hydraulic line/wing skin/wheel temperatures, tire pressure, and landing gear downlock position indication) in the final minutes prior to the Orbiter’s breakup provided failure signatures supporting the leading causal scenario of left wing thermal intrusion, as opposed to a catastrophic failure (extensive arc tracking) of Kapton wiring. Actual NASA testing in the months following the *Columbia* tragedy, during which wiring bundles were subjected to intense heat (hot

Figure 1.1.3. Wire Bundle Comparison.

oven, blowtorch, and arc jet), verified these failure signature analyses. Finally, extensive testing and analysis for years prior to STS-107 showed that, given the low voltages and low currents associated with the Orbiter's instrumentation system (such as those in the left wing), the probability of arc tracking is commensurately low.

Based on the extensive wiring inspections, pre-STS-107 maintenance and modifications, analysis of sensor/wiring failure signatures, and the lack of alignment of catastrophic wiring failure with any of the likely failure modes, the presence of Kapton wiring in *Columbia* is highly unlikely to be causal.

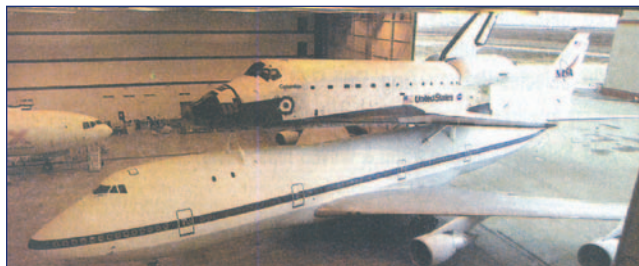
Figure 1.3.4. An Orbiter and SCA partially inside a hangar in Palmdale.

vertical clearance limits, the tails of both craft remained exposed (See Figure 1.3.4). After arrival at KSC, 112 pounds/14 gallons of water were removed. The same February 2001 rainstorm at Palmdale also affected OV-104, which had recently landed (February 20/STS-98) and was being prepared for its ferry flight to KSC. OV-104's "aft fuselage under bay 6 [was] full of standing water" and water was "five inches deep along [the] back of 1307 bulkhead;" 1,600 pounds (200 gallons) were removed after its arrival at KSC.

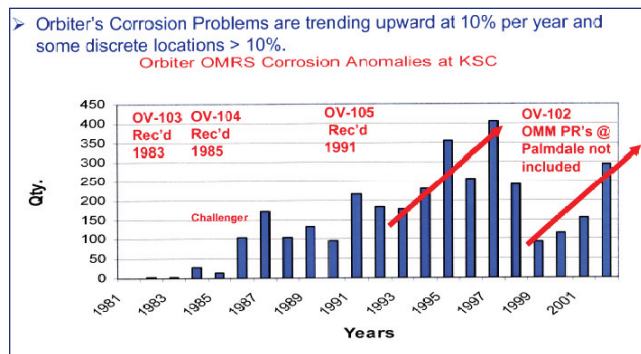
The environment at KSC is about as challenging, from a corrosion perspective, as exists. The necessity to control exposure is reflected in the amount of work needed to keep the Orbiters in a mission-ready condition. Corrosion, in general, is trending upward for the Orbiter fleet by 10 percent annually, and there is a marked increase in corrosion in areas such as the body flap cove (one of the lowest points when the Orbiter is in a vertical orientation). Figures 1.3.6 and 1.3.7 show these corrosion increases, one classic symptom of aging aircraft.

Figure 1.3.6. Increasing orbiter corrosion trends.

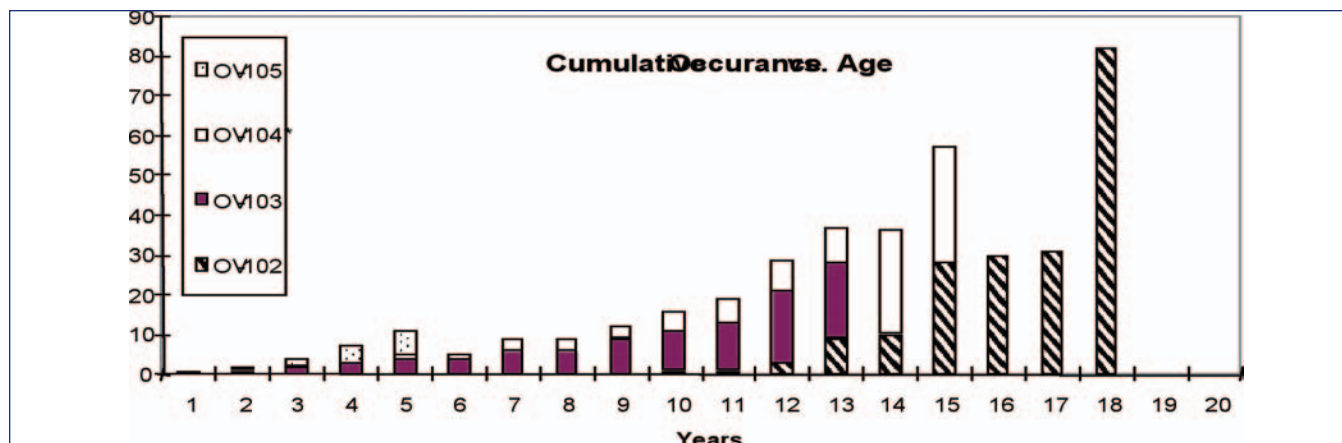
While corrosion is symptomatic of normal aging, in the Orbiter's case, its location at the aft (lowest point in its launch configuration) shows the effect of launch pad exposure. The body flap cove and surrounding area, as well as associated hardware, are showing significant growth in man-hour consumption to grind out corrosion pits. Components, such as the body flap actuator, illustrate the increasing challenge posed by corrosion and the impact on logistics and spare parts availability. Over the last several years, body flap actuators have been removed for corrosion. During repair, internal corrosion has also been discovered, with some piece parts being beyond repair. Manufacturing new piece parts entails extensive lead times, in some cases years. Status of body flap actuators at the end of April 2003 was seven in inventory, with four installed; two had been removed and were in the repair cycle, along with the only spare; the first serviceable spare was projected to be available in June 2003.

Figure 1.3.7. Fleet corrosion in body flap cove area.

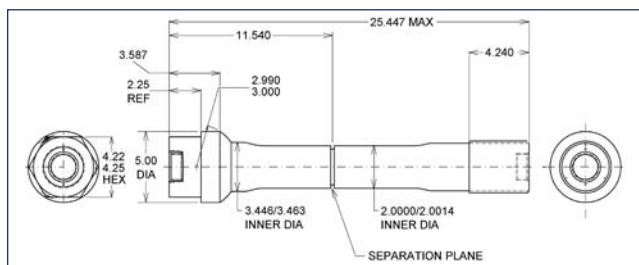
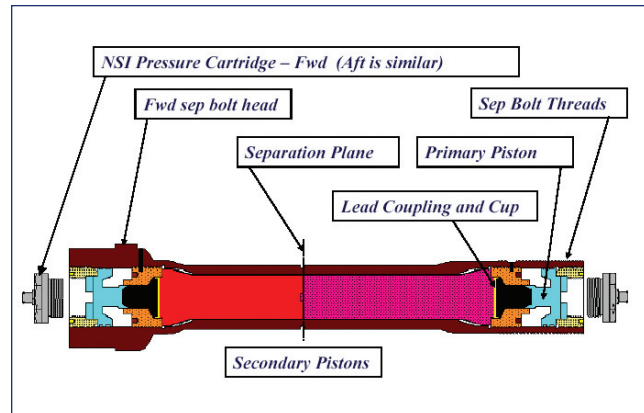
Figure 1.6.1. Separation Bolt.

Figure 1.6.2. Separation bolt cross section.

been done without adequate NDI (magnetic particle) of the internal bore. (See Figures 1.6.1 and 1.6.2.)

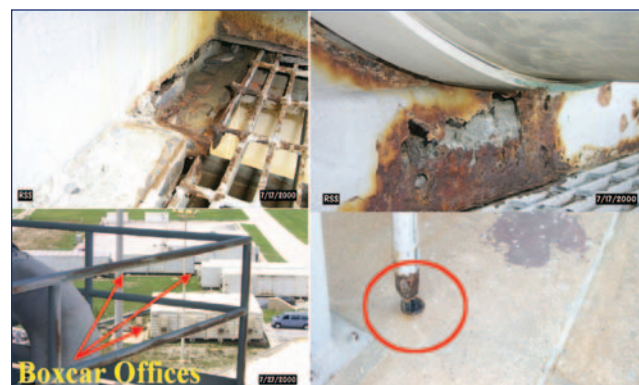
structure, which serves as the core of the Fixed Service Structure (FSS), was designed and built in the Apollo era and incorporates older designs which trap fluids, including corrosives, even after post-launch wash downs, as well as precipitation. To their credit, ground systems support personnel and engineers recognized these design problems a long time ago, and newer modifications/replacements, such as the Rotating Service Structure (RSS), are better designed, without fluid traps. As the pads have aged and modifications/upgrades have been incorporated, many of the older systems have been abandoned in place; there is evidence of old clamps, conduits, mounting brackets, and other hardware that continue to corrode. This can be problematic, as continued degradation of these abandoned systems can contribute to loose debris during launch, posing a hazard to the shuttle. Again, to the ground support systems management's credit, they have recognized this and have lobbied for/received funding to remove formerly abandoned-in-place hardware; while much has been done, much remains and efforts are continuing. On each pad's RSS, the Payload Changeout Room's walls of foam core sandwich construction are deteriorating due to acoustic loads during launch. While repairs have been accomplished using a multitude of through-bolts, these are at best temporary and add needless weight to the movable structure. A more permanent repair will require serious consideration of an alternative design to ensure durability. There is also extensive concrete deterioration at the pad base and blast deflector areas; these are repaired from launch to launch. KSC has 83 railroad boxcars at pads 39A and 39B. These were procured for their durability and are used as offices and work centers for support personnel. Unfortunately, they are extensively corroded and ceiling leaks/buckled floors can be seen in various locations. To KSC's credit, they are correcting this situation with the construction of new facilities at each launch pad that will completely replace the boxcars; move-in is scheduled for FY2003.

Figure 3.2.1. Launch Pad Corrosion and Boxcar Facilities.

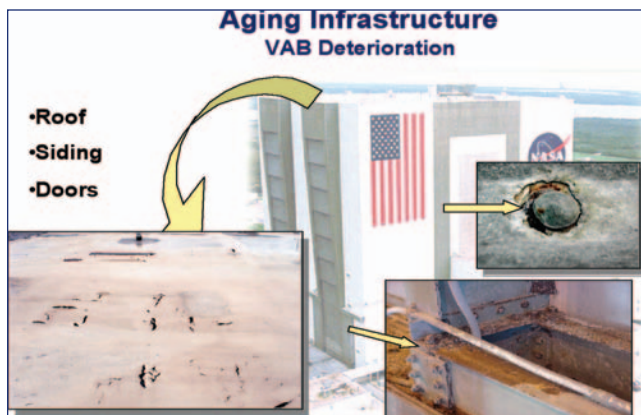
Example 2: The Vehicle Assembly Building (VAB) is the only facility of its kind in the world and a critical element of the Space Shuttle Program. It is where the Orbiter, External Tank, and Solid Rocket Boosters are mated and demated. It was constructed in the 1960s for Saturn V buildup. Like the launch pads, it serves as an example of both the problems faced by the SSP and NASA in maintaining aging infrastructure, as well as ongoing efforts to meet these challenges. The 5-acres of roof from its original 1964 construction are comprised of 6 inches of foam and vinyl layers added over the concrete slab through the years. Regular repairs are accomplished on the roof's outer surface using sealant and asphalt paper. Roof leaks over the years have led to deterioration (spalling) of the concrete ceiling on the interior of the roof slab, with concrete fragments occasionally falling loose from a height of over 500 feet. This FOD hazard has been mitigated by the installation of a subdeck five feet below the ceiling to catch debris and safety nets at lower levels. A comprehensive repair effort has been funded for FY2004 to remove all roof outer layers down to the original slab and recover with sloped roofing boards and a synthetic membrane, as well as repairs to the interior concrete ceiling. Significant portions of the VAB's 1.1 million square feet of siding also require repair due to corrosion; this is especially critical due exposure of this vast surface area to hurricane-force

Figure 3.2.2. Vehicle Assembly Building.

winds; repairs are scheduled for FY2006. Several of the VAB's massive multi-panel doors require extensive corrosion repair. The structure's overhead bridge cranes are a mix of 1960s and 1990s vintage equipment, but are effectively sustained through regular maintenance due to their critical role in mating/demating operations.

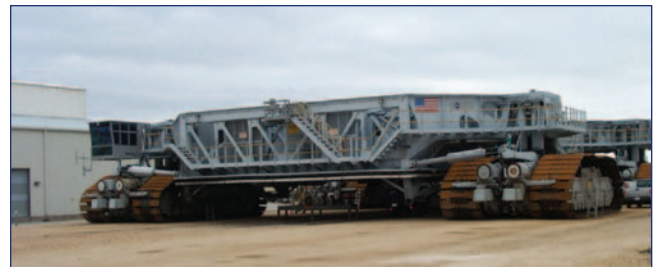
Example 3: Two of the Shuttle Program's most critical pieces of equipment, the Crawler/Transporter (CT) systems, pose a significant technical sustainment challenge. (See Figure 3.2.3) These unique vehicles are necessary to move the stacked Space Shuttle to and from the launch pads. During hurricane season – roughly half of the year starting in early summer – both must be up and running in the event Shuttles must be moved from the pad back to the VAB for "safe haven." This precludes extensive maintenance during this entire period. Built in 1965, the CTs each average over 1,700 miles. They have received incremental capability upgrades over the years, including a laser docking system, computerized control stations, and replacement control cabs. The massive hydraulic actuators used to jack, level, and carry the Mobile Launch Platform (MLP) and Shuttle Stack were recently refurbished for the first time. Obsolescence of purpose-built components poses a major challenge, and will continue to need correction through upgrades. Corrosion is a significant problem due to no sheltered storage, and maintenance is frequently suspended due to severe weather. As support costs rise due to aging and obsolescence, it was noted that managers track resources expended (costs of modifications/parts/labor) over time, but do not do so per unit of output (miles driven or operating hours). While costs over time will always increase, a more valuable metric is cost per unit of output, as this can be used for analysis and trending and can help in more clearly comparing the cost/benefit tradeoffs of inaction, modification, or replacement.

Figure 3.2.3. Crawler Transporter (CT).
